March 18, 2014

EIFS Cladding Evaluation

Anytown USA
IL, IA, WI, IN, MI

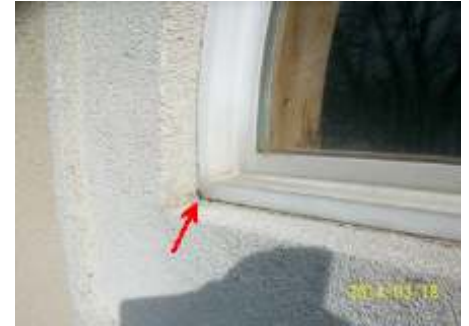
Gable window has never been sealed.

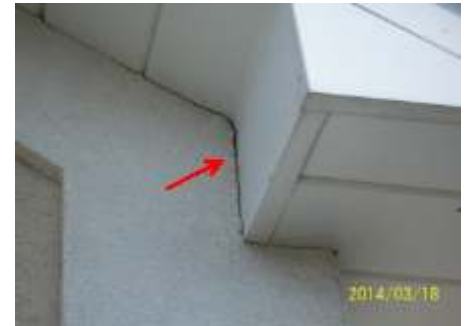
Soffit & Fascia should be sealed.

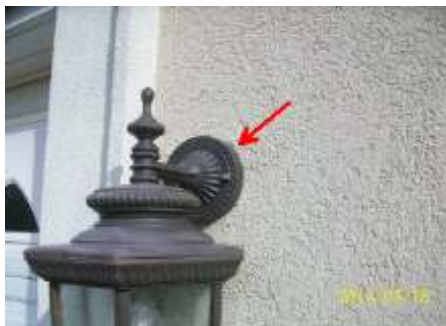
Light fixtures should be sealed.

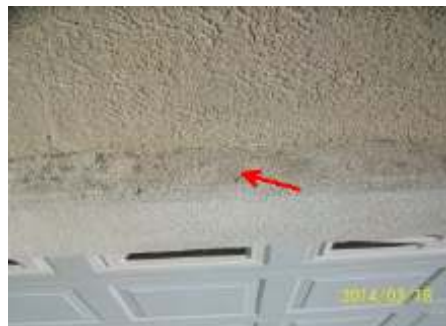
EIFS flat accents should be waterproofed.

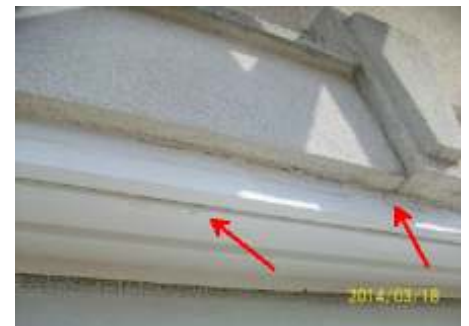
Evidence of moisture weeping from garage door header. Rotted wood.

Grid Location	Item Description	Moisture Readings	Substrate Condition	Observations/Comments
D4	Windows	16	Soft	Wood feels dry rotted at both locations.
D5	Door Header	12	Soft	Open door head to find moisture source. Remove any moisture damaged wood. Replace the siding system with drainage.
				Dormers see next page.

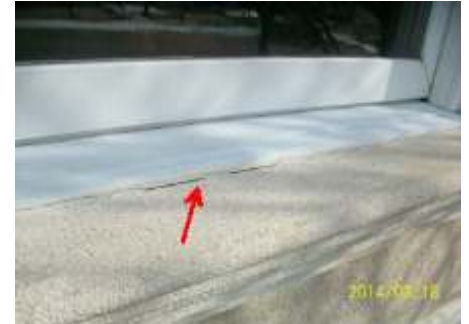
Gaps at flat window sills can allow for moisture to enter the wall assembly.

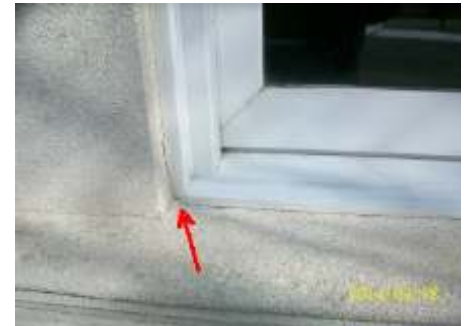
Minimal use of sealant has failed.

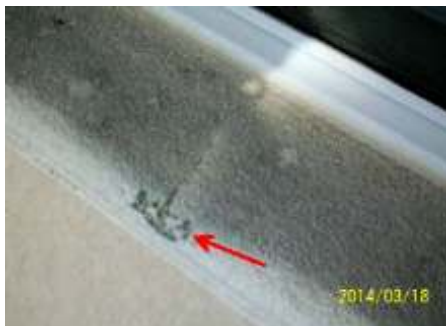
Repair bull nose sill damage.

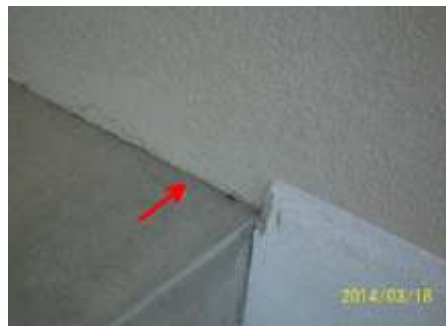
Recommend sealing the front stoop EIFS Junction.

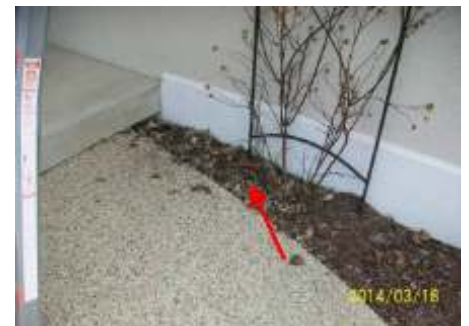
Pull mulch and landscape materials away from the siding.

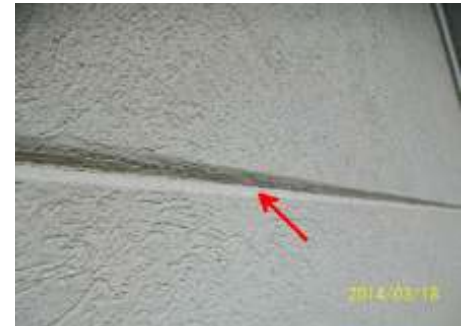
Architectural groove is not a proper expansion joint.

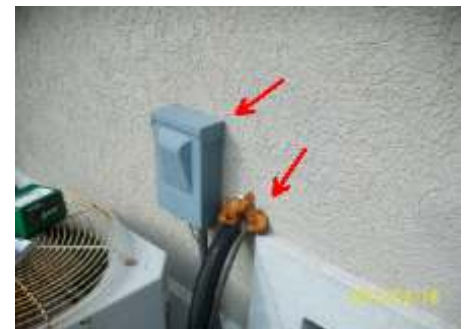
Unsealed or improperly sealed utilities.

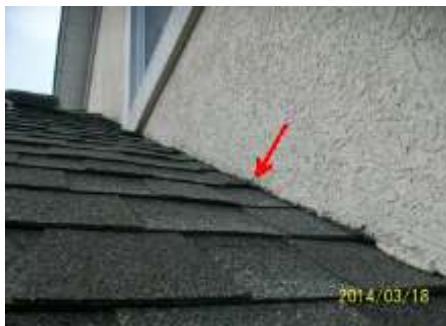
Improper roof line termination.

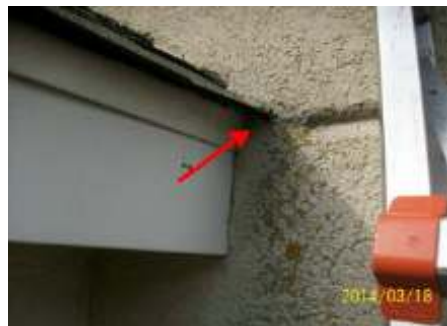
Missing kickout flashing.

Kickout flashings have not been installed. Recommend installing new manufacture approved kickout flashings at all primary and secondary locations per manufacturer specifications.

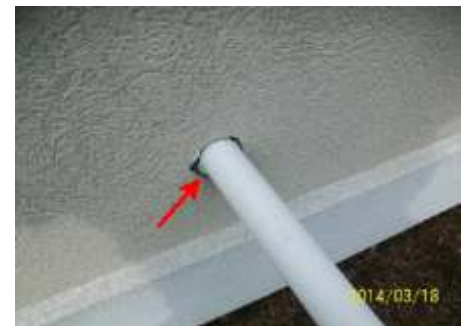
Piping penetrations should be sealed.

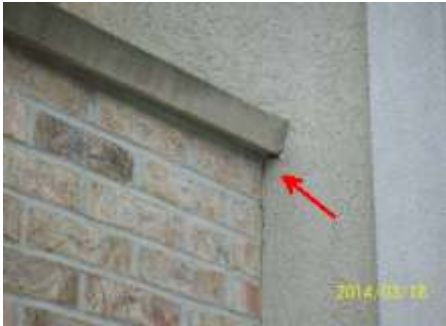
EIFS / Chimney junctions should be sealed.

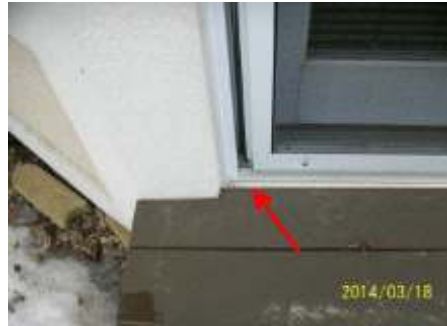
Unable to test under rear door due to wooden step.

Grid Location	Item Description	Moisture Readings	Substrate Condition	Observations/Comments	
C7	Windows	23	Soft		
D7	Windows	40	Soft		
G7	Windows	23	Firm		
I6	Windows	22	Firm		
				The wood step prevented testing under the rear door. We suspect this area is also moisture damaged and will need to be evaluated for repair.	Orange outline

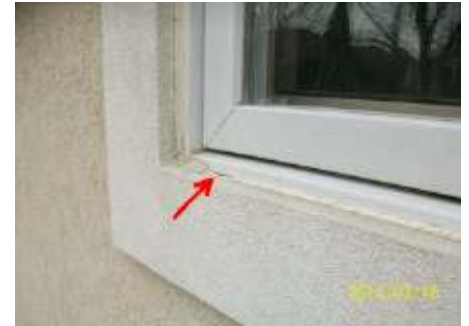
Gaps in old window sealants.
